10 193

HAIL RESISTANCE TESTS OF ALUMINUM SKIN HONEYCOMB PANELS FOR THE RELOCATABLE LEWIS BUILDING, PHASE II

April 10, 1970

by Robert G. Mathey

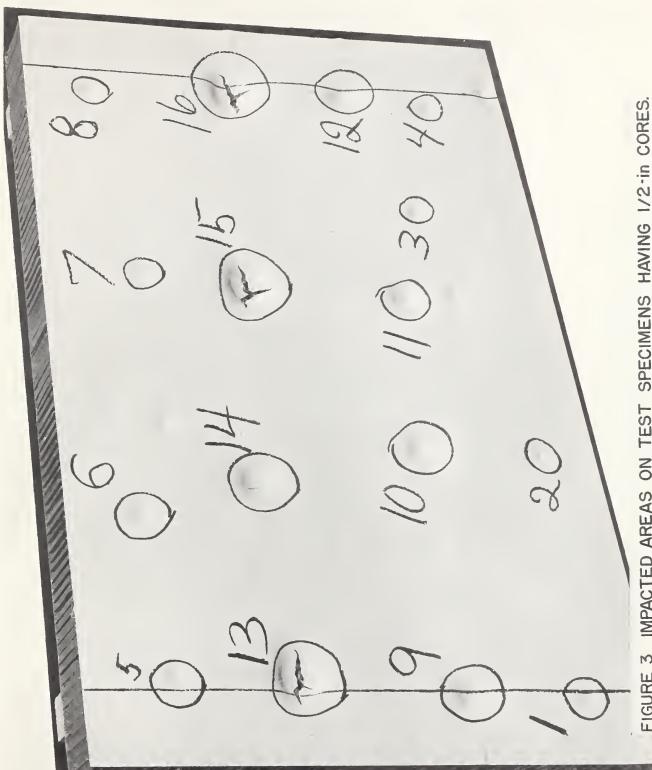
FIGURE 3 IMPACTED AREAS ON TEST SPECIMENS HAVING 1/2-in CORES.

The diameter and depth of the indentation in the test specimens shown in Figures 3 and 4 along with the weight, velocity, impact location, and kinetic energy of the hailstones are given in Table 3. This table also includes information on cracking in the test specimen due to impact of hailstones. The values in this table are average values for two test specimens. It is noted in Table 3 that there are two values given for the diameter of indentation. The sketch in Figure 6 depicts the typical cross section of an impacted area of the skin of the honeycomb panel. The overall diameter and indentation diameter of the impacted area are shown on the sketch.

In comparing the average indentation diameter, average overall indentation diameter, and the average depth of indentation given in Table 3 for panels having 1/2 and 3/4-inch cores, it can be seen that there was little difference in the hail resistance of the two panels. Only in the case of the indentation caused by the 2 1/2-inch diameter ice spheres was there a noticable difference in performance of the panels to resist large size hail. The panels with the 1/2-inch cores developed smaller indentations, however, damage was very extensive for both types of panels. The location of impact with regard to supported or unsupported areas on the test specimens also had no appreciable effect on the hail resistance.

Both types of panels with the 1/2 and 3/4-inch cores resisted the 1 1/2-inch diameter hailstones without developing cracks or breaks in the aluminum skin. The kinetic energy of the 1 1/2-inch diameter hailstones traveling at the resultant velocity (terminal velocity combined with a 45 mph wind) was 11.7 ft-lb. The average depths of indentations caused by the 1 1/2-inch diameter ice spheres ranged from 0.17 to 0.25 inches for the terminal and resultant velocity respectively. These indentations at both supported and unsupported areas after affect the appearance but not the performance to resist penetration of moisture or water.

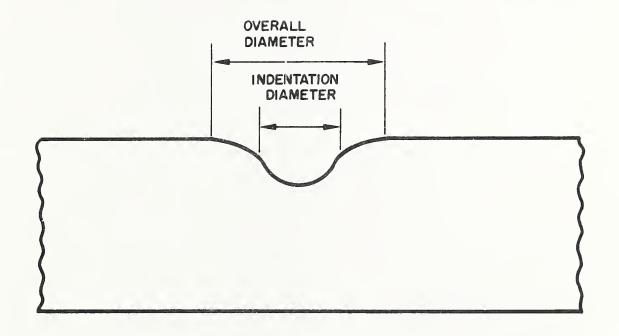
FIGURE 6 CROSS SECTION VIEW OF TYPICAL INDENTATION IN ALUMINUM SKIN HONEYCOMB PANEL TEST SPECIMENS
